Questar Pipeline Co.

**Mainline 104 Extension
to Fidlar Project**

Description

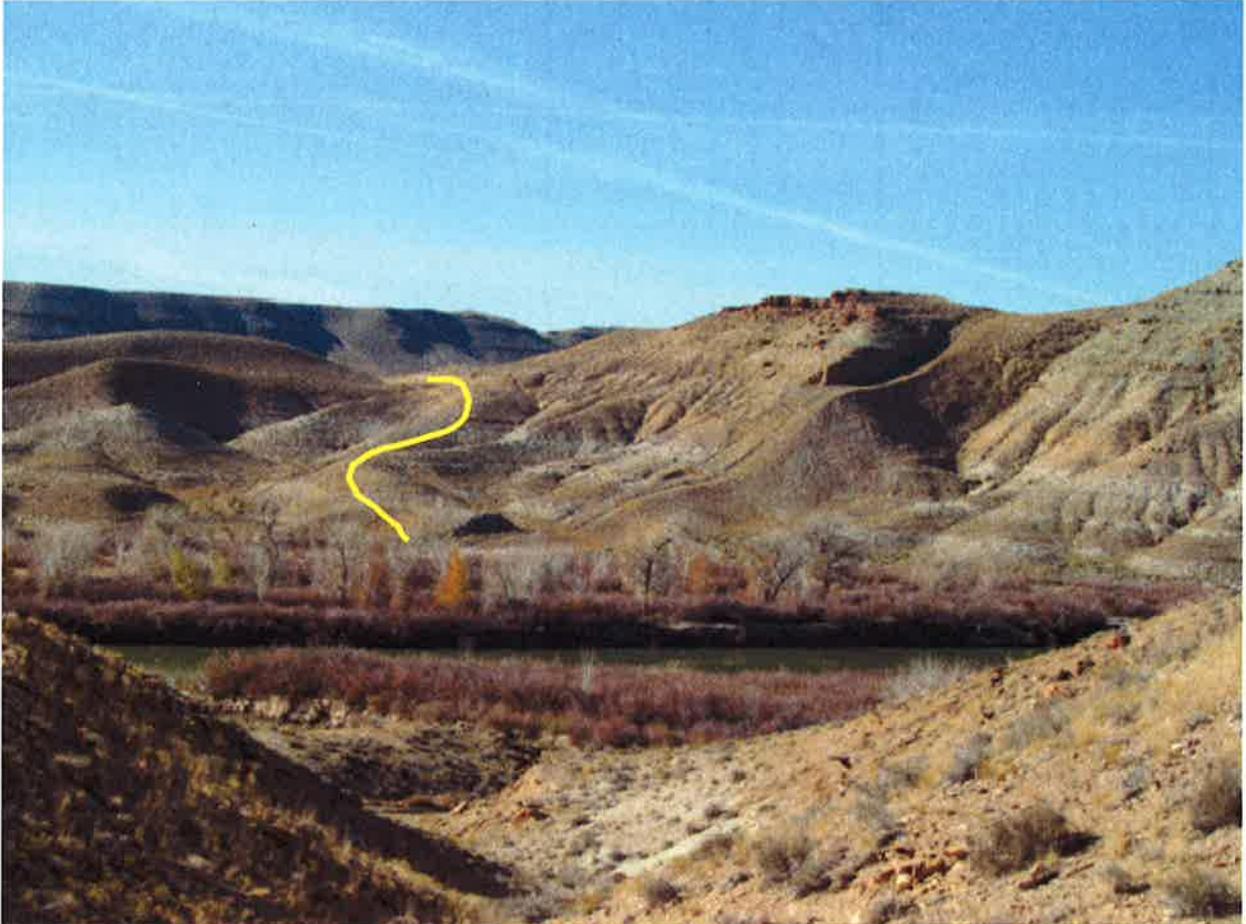
Yellow line marks path of project. What appears to be disturbance on right is unrelated to Questar's project.

Questar maintained existing riparian vegetation along the river to provide a visual barrier between a casual observer from the river and construction activities. The pipeline was routed down the west side of the Green River valley in an existing draw and along a two-tracked/bladed road to reduce the potential visibility of the crossing. The road was reclaimed at the end of construction with agency approval to further improve the existing visible condition.
